Report No. CG-D-02-16

Initial Burn Pan (JMTF) Testing Results

March 2016

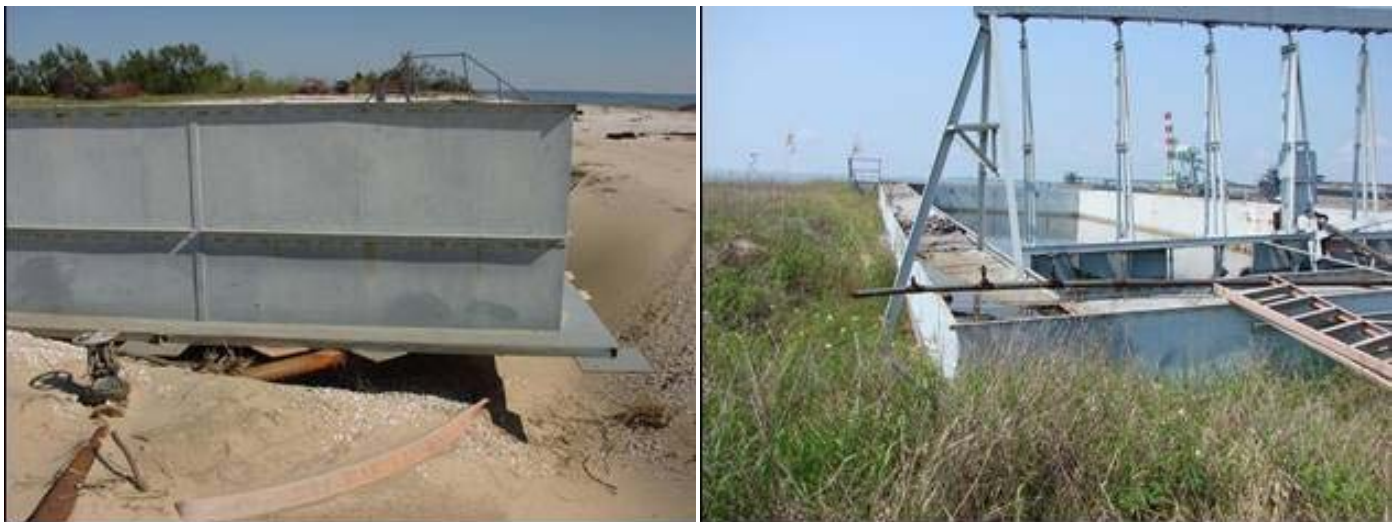
The burn pan was fabricated out of steel and installed in 1998 on Little Sand Island (Figure 2). The outer burn pan is approximately 33.0 m (108 ft) long, 11.6 m (38 ft) wide and 1.5 m (5 ft) deep. The 1.02 m (4 ft) wide trough separates the inner burn wall from the outer wall. The inner burn pan is approximately 30.5 m (100 ft) long, 9.2 m (30 ft) wide and 1.5 m (5 ft) deep. About 4.9 m (16 ft) of the north end of the burn pan is occupied by the wave generator which features a wave paddle suspended by a support structure 4.9 m (16 feet) above the tank floor (seen to the left in Figure 1 and to the right in Figure 2). The top of the trough is covered with deck grating and serves as a walkway around the top of the burn pan (Bitting 1999). Testing in Figure 2 shows a boom constrained from horizontal movement by several stanchions anchored to the bottom of the tank. It was instrumented with temperature and heat flux gauges. The last full test was in 1999. Figure 3 shows damage to the tank from hurricanes that flooded the island in 2005.

Figure 3. Burn pan showing sand removed from base and disconnected pipes (left) and other damage (right).

The ISB burn pan on LSI was re-leveled and repainted; and the surrounding ground cleared to prepare for this test. As mentioned above, the burn pan consists of a pan-in-a-pan design where the inner pan is the actual fire pan and the outer trough is filled with water to provide cooling of the fire pan walls. Figure 4 shows the interior of the refurbished burn pan. There are a number of piping interfaces that were originally installed on the burn pan to provide access for the various subsystems on LSI, such as fuel input and water draining. Since these subsystems were also destroyed by Katrina, the interfaces were sealed off during this test program. However, two new spool pieces were added during this refurbishment on the east side of the burn pan to provide access for the fuel pipe and instrumentation.

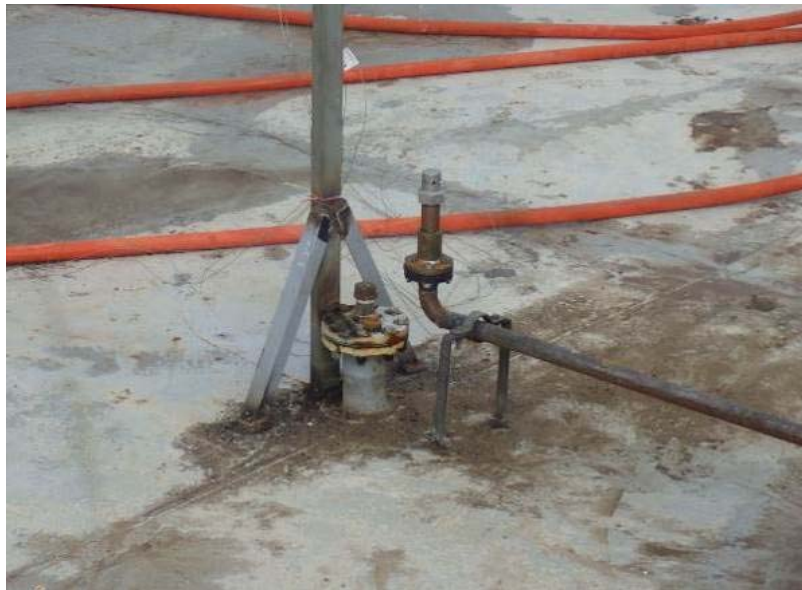
A spool piece was welded to the burn pan to span the outer chamber and to provide a flanged fitting inside the burn pan. A separate piece made of steel was fabricated to go inside the burn pan, including a riser to allow the discharge of the fuel just below the water surface. A nozzle with six, 1.0 cm (0.38 in) diameter holes around the perimeter was installed on the riser to provide an even distribution of fuel below the water surface inside of the boom. The riser and fuel nozzle are shown in Figure 7; and the test configuration is shown in Figure 8.

Figure 7. View of fuel nozzle.
